UNDERWATER FACILITIES INSPECTIONS & ASSESSMENTS

DEGAUSSING RANGE
NAVAL STATION
MAYPORT, FLORIDA

FPO-1-84(10)

MARCH 1984

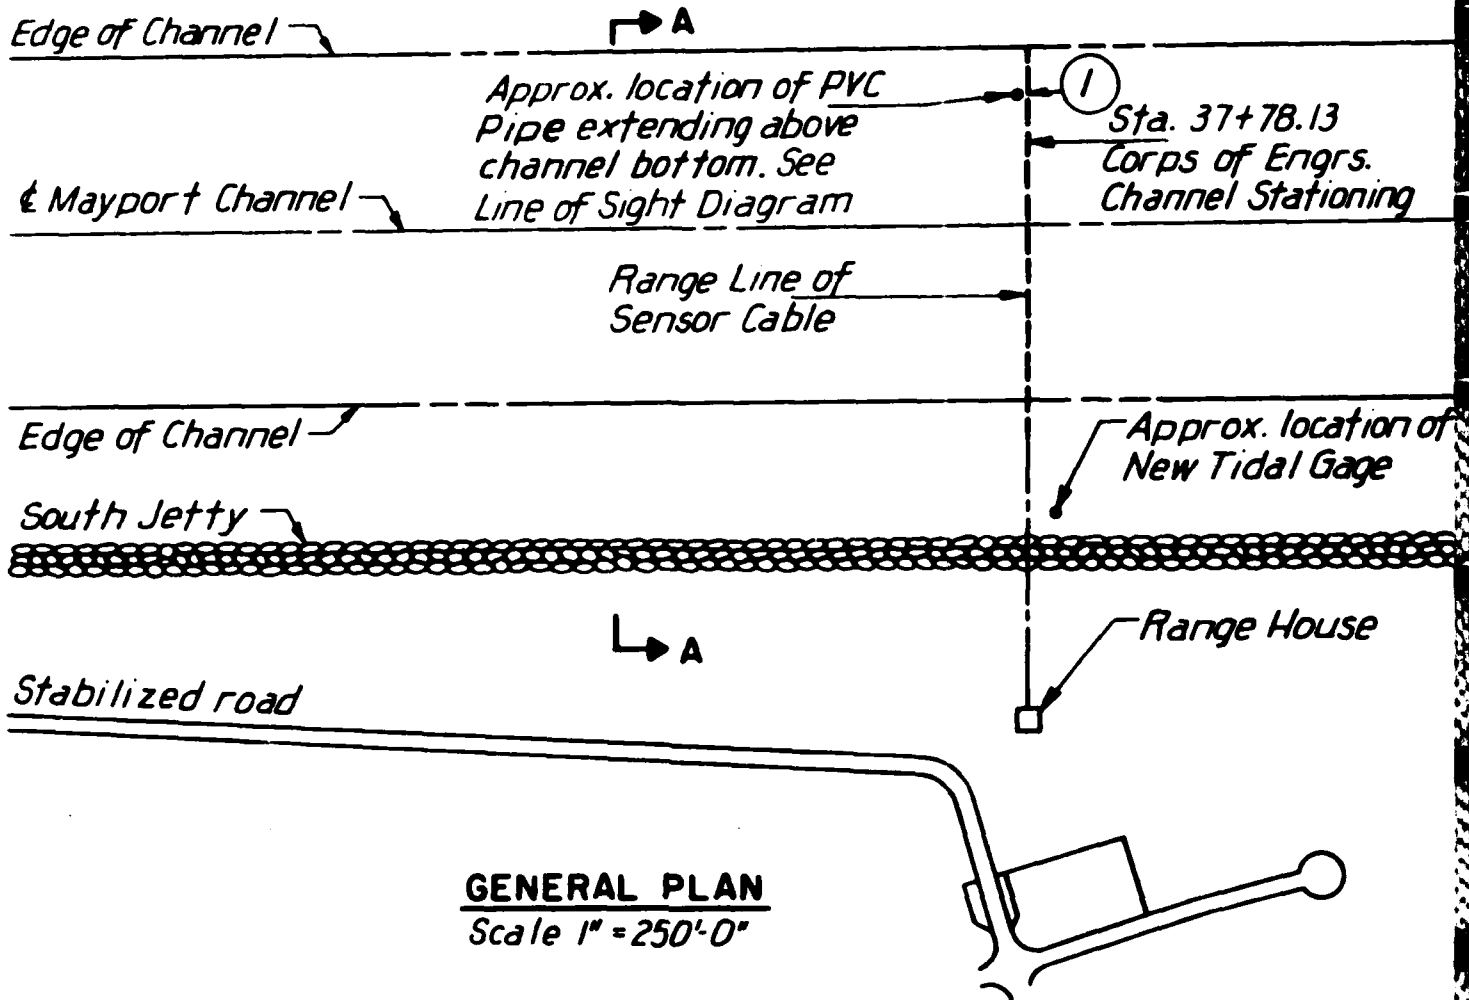
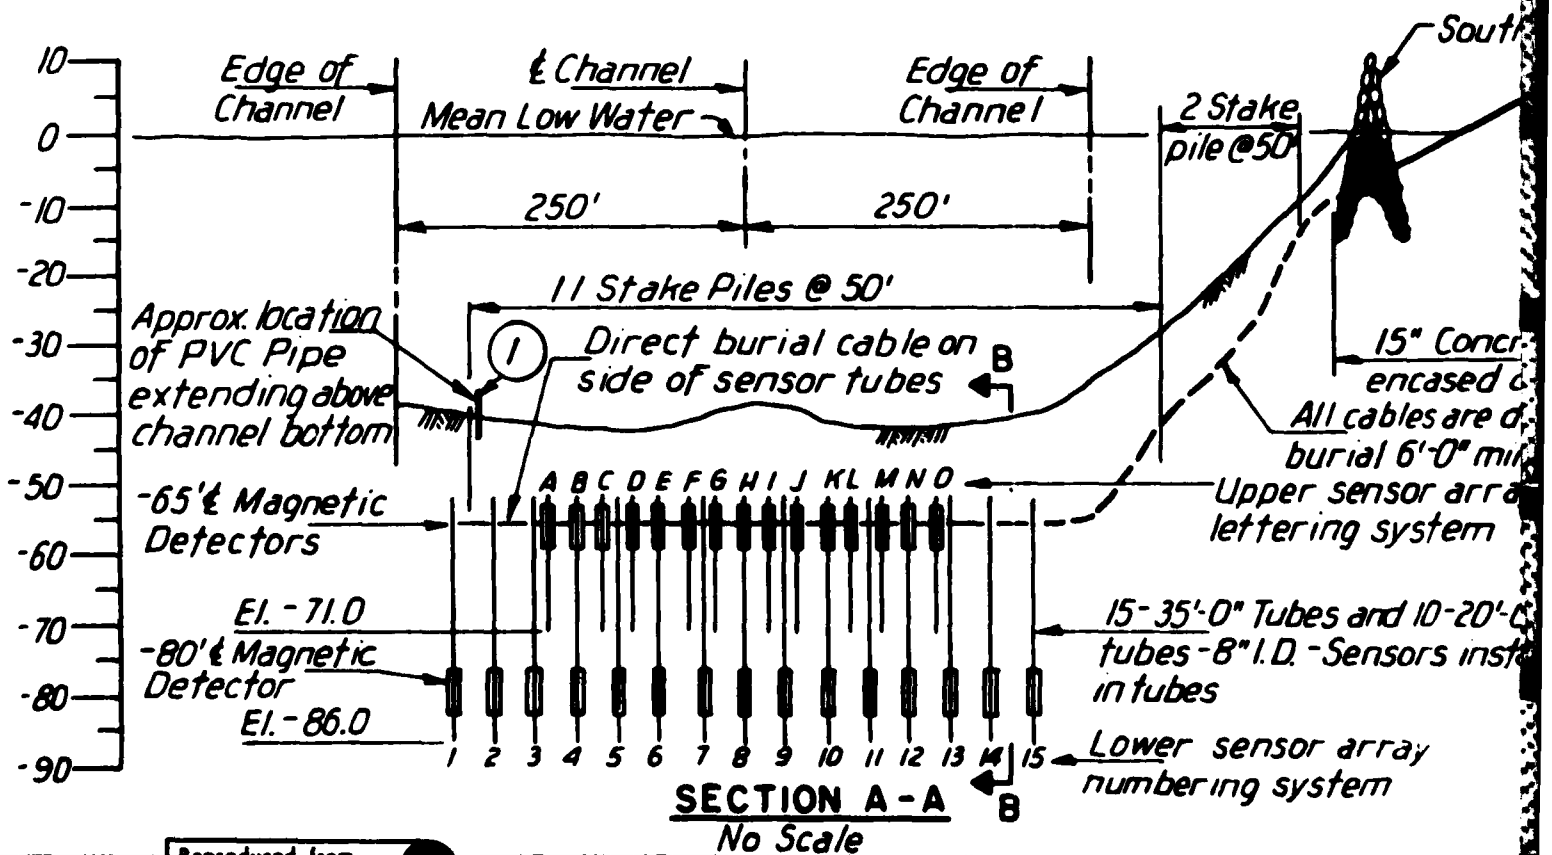
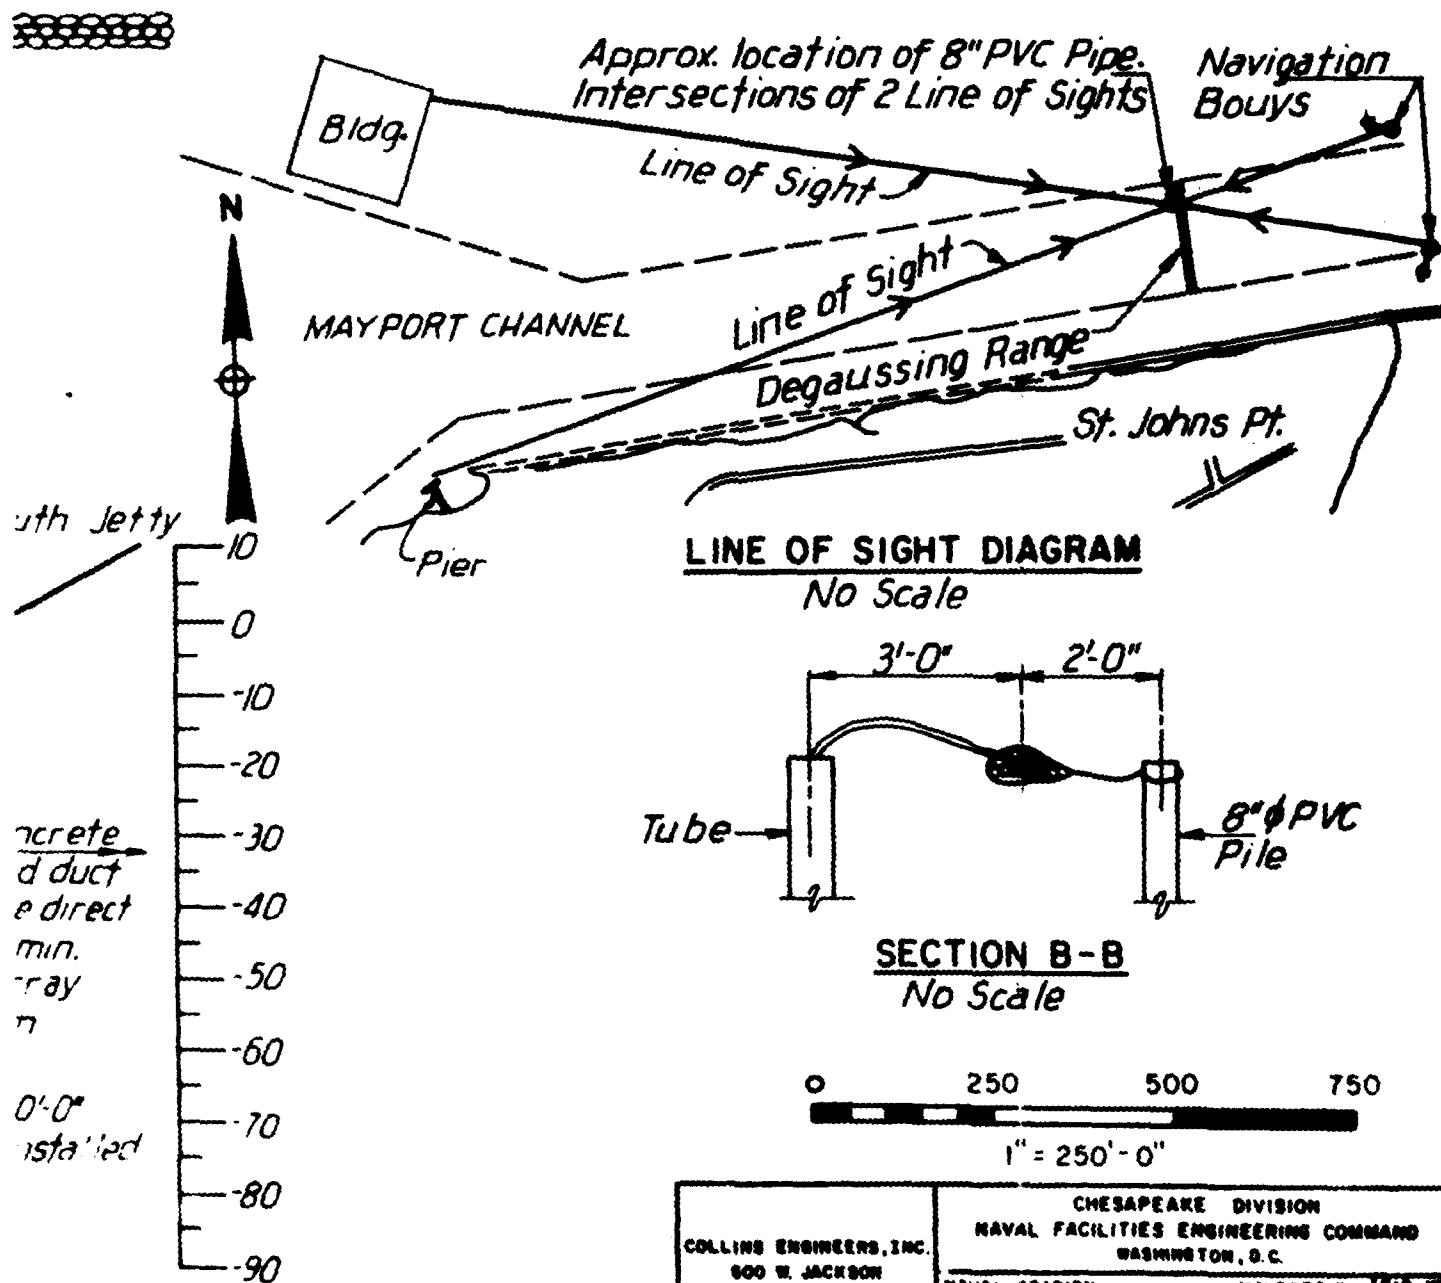
COLLINS ENGINEERS, INC. 600 W. JACKSON CHICAGO, ILLINOIS	CHESAPEAKE DIVISION NAVAL FACILITIES ENGINEERING COMMAND WASHINGTON, D.C.	
	NAVAL STATION DEGAUSSING FACILITY	MAYPORT, FL FILE NO. 4

The inspection of the area of the cable runs between the shore and the sensor tubes did not detect any scouring or unburying of the cables. The eleven degaussing range stake piles and thirty magnetic sensor tubes were also buried. One PVC pipe was found along the range but is not known if this is one of the stake piles. This pipe extended approximately two feet above the channel bottom, and nothing was attached to the exposed pipe. Refer to Figure 4 on page 4-2 for the location of this pipe and to Photograph 1 for a view from shore.

- ① 8" PVC Pipe extending 2'± above channel bottom;
No cables exposed

Correlation of the sounding data with the original design drawings for the facility indicate that the present channel bottom is above the cable runs and magnetic sensors.

The cable runs and magnetic sensors were found to be buried. No deficiencies were detected.

It is recommended that future periodic reinspections of this facility be scheduled on 5 year intervals to monitor the long-term serviceability of these structures. No repairs are recommended at this time.
